INDOOR AIR QUALITY ASSESSMENT

**Massachusetts Office of Information Technology
One Ashburton Place, 8th floor
Boston, MA**

Prepared by:
Massachusetts Department of Public Health
Bureau of Environmental Health
Indoor Air Quality Program
February 2017

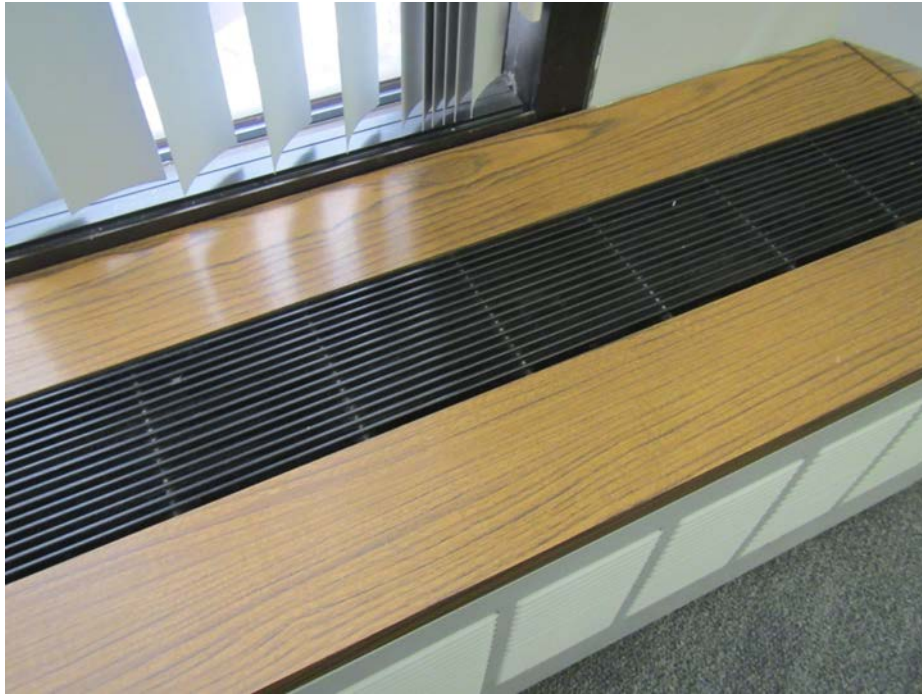
Picture 1

Fresh air is supplied by induction units located along the outer edges of the building (Pictures 1 through 3). Return air is drawn through grates or around light fixtures using ducted returns. As shown in Pictures 2 and 3, some induction units had items on top of them, which can obstruct the flow of fresh air. In addition, some of the items on/near the vents of the induction units can be a source of dusts, odors and, in the case of plants, pollen and other potential allergens. Induction unit vents should be kept free of items and kept clean.

Induction unit

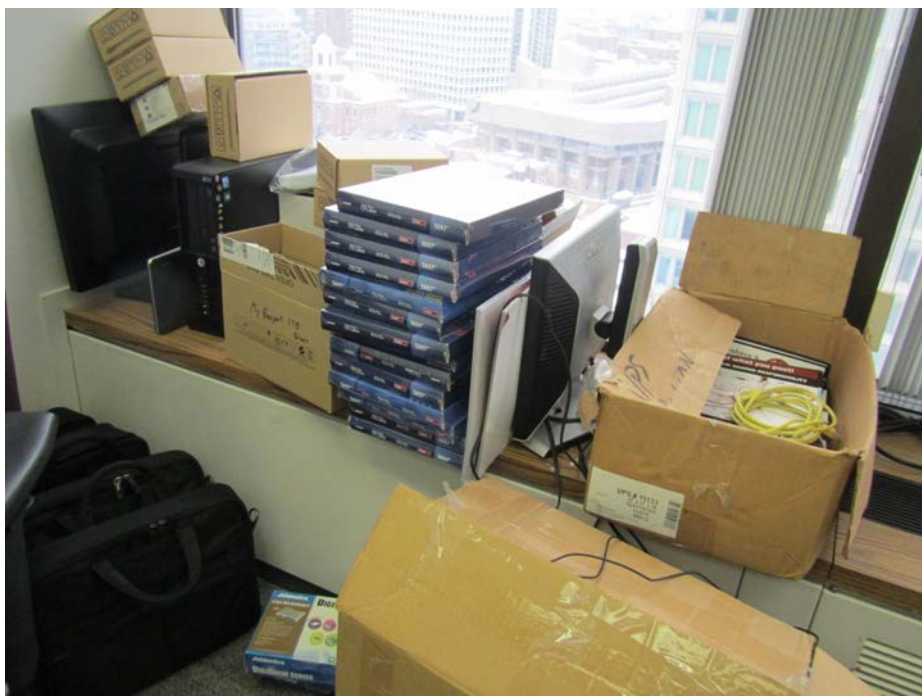
Picture 2

Induction unit with items on top and in front

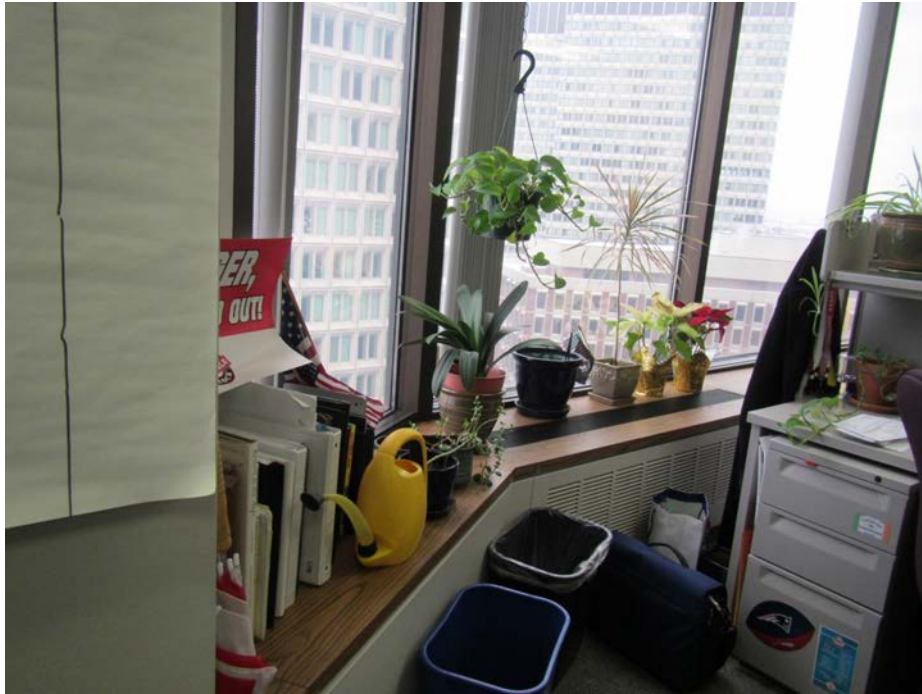
Picture 3

Plants were noted in a few areas (Table 1; Picture 3). Plants can be a source of pollen and mold, which can be respiratory irritants to some individuals. Plants should be properly maintained and equipped with drip pans and should be located away from induction units to prevent the aerosolization of dirt, pollen and mold.

Induction unit with plants

5. Keep plants in good condition, avoid overwatering, and remove from the airstream of heating and ventilation equipment.
6. Reduce the use of cleaning products, sanitizers, and other items that contain VOCs.

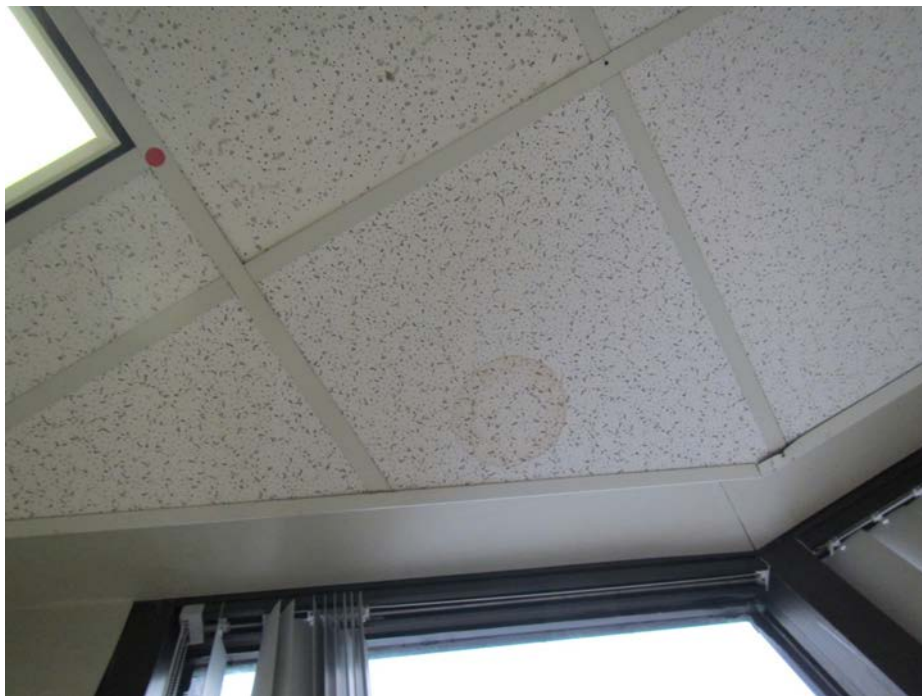
Picture 4

A few water-damaged ceiling tiles were observed in offices with windows (Pictures 4 and 5). These indicate past leaks through the building envelope. Water-damaged tiles should be replaced once they are detected. In two offices, new/different wall paneling was observed (Picture 5), which was reportedly installed following more significant leaks more than a year prior to this visit. No musty/moldy odors were observed in these areas.

Water-damaged ceiling tile

3. Have the HVAC system balanced every 5 years in accordance with SMACNA recommendations (SMACNA, 1994).
4. Replace water-damaged ceiling tiles once the source of the leak is repaired. Ensure that any leaks are reported to building management promptly so drying and other remediation can take place.

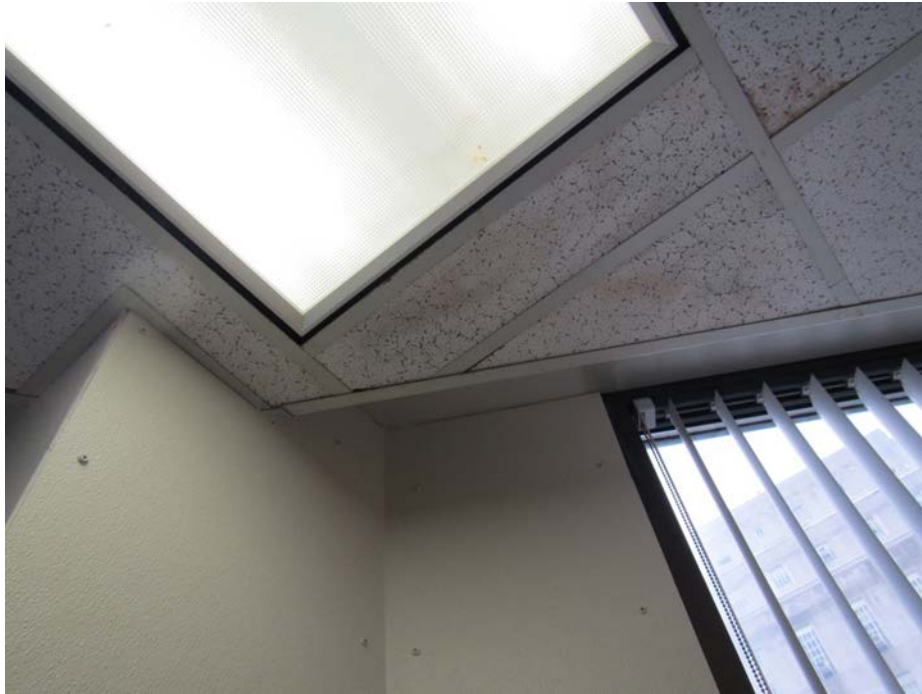
Picture 5

Water-damaged ceiling tiles and new wall paneling (note screws attaching to wall)

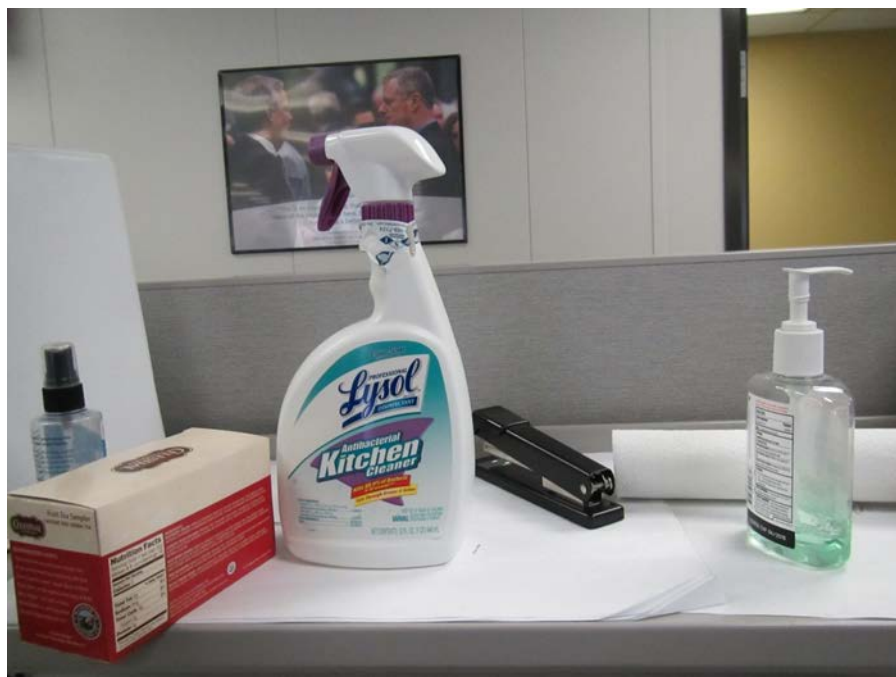
Picture 6

Exposure to low levels of TVOCs may produce eye, nose, throat, and/or respiratory irritation in some sensitive individuals. In addition to testing, BEH/IAQ staff examined spaces for products containing VOCs. BEH/IAQ staff noted air fresheners, deodorizers, hand sanitizers, cleaning products, compressed air canister, and dry erase materials in a number of areas throughout the office space (Table 1; Picture 6). All of these products have the potential to be irritants to the eyes, nose, throat, and respiratory system of sensitive individuals.

Cleaning product and hand sanitizer

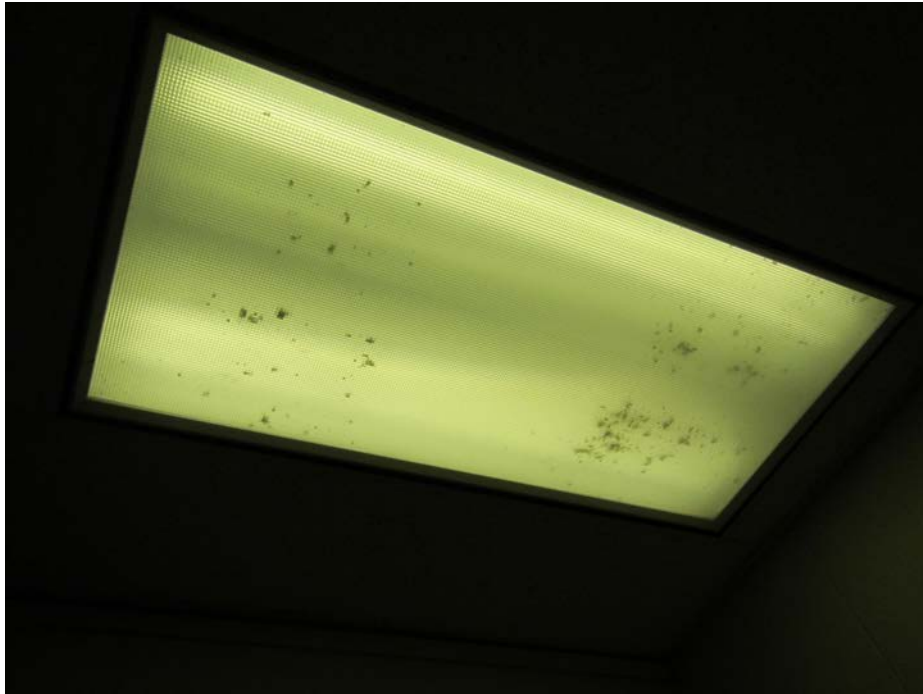
Picture 7

Some of the fluorescent light fixtures had debris visible inside them (Picture 7). These fixtures should be cleaned periodically, and care should be taken to avoid distributing the debris when the fixtures are opened. In addition, any debris dislodged during cleaning should be vacuumed using a HEPA-equipped vacuum afterward. This activity should be conducted outside of normal working hours.

Debris in light fixture
